# Manhole Inspection Summary

Manhole # S53AA\_031MH

Insp Date: **7/16/08 2:06 PM**

**Location** Address: **538 n highland av**

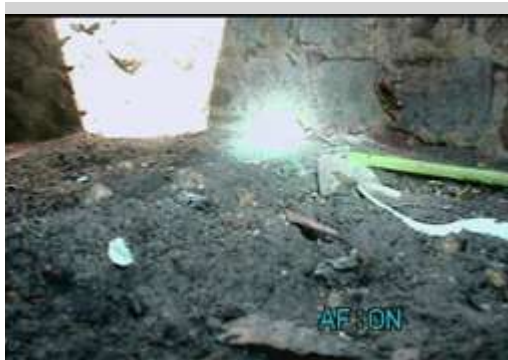
Defect 4

Condition: ☐ Sound ☐ Cracked ☐ Root Intrusion ☐ Deteriorated ☐ Leaks ☒ **Debris**

bench debris

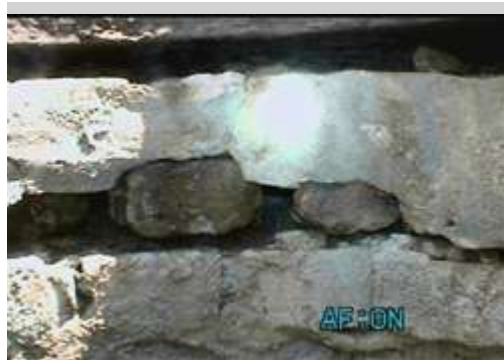
Defect 3

**Chimney / Frame Adjustment** ☒ Exists Material: **Brick and Concrete** ☐ Parged Height: **5** (in.)

Condition: ☐ Sound ☒ **Cracked** ☐ Root Intrusion ☒ **Loose Brick** ☐ Deteriorated

chimney loose bricks, cracked, frame adj

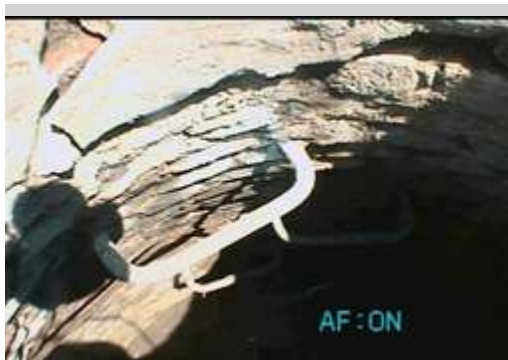
Defect 2

**Steps** Count: **3** Missing: **0** ☒ **Corroded**

steps

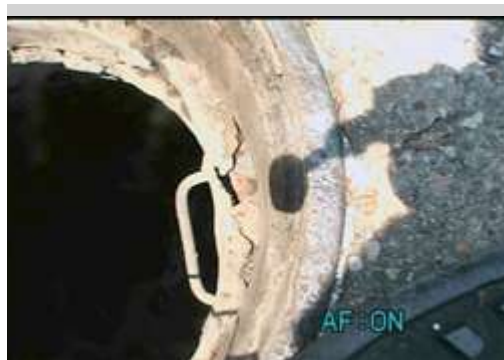
Defect 1

**Frame** Offset: **2** (in.) Condition: ☐ Sound ☒ **Cracked** ☐ Leaks

offset and cracked frame

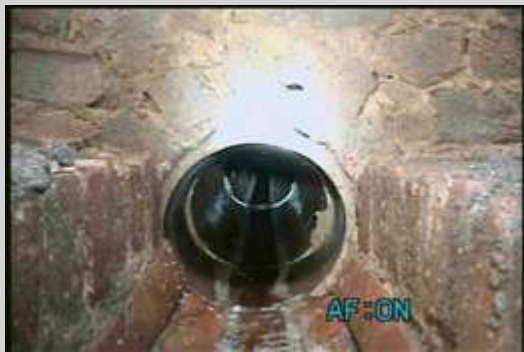
12 O'Clock Outflow

8 in. Circular Gravity Sewer  
Pipe Out @ 12 O'Clock

Invert Depth: 7.20 (ft.) Flow Characteristics: **Fast**

Deposits: ☒ None ☐ Mud ☐ Sludge ☐ Debris ☐ Grease

Infiltration: **None** Pipe Seal Cond: **Unknown**

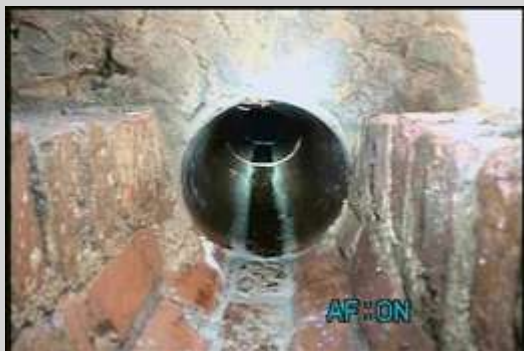
6 O'Clock Inflow

8 in. Circular Gravity Sewer  
Pipe In @ 6 O'Clock

Invert Depth: 7.10 (ft.) Flow Characteristics: **Fast**

Deposits: ☒ None ☐ Mud ☐ Sludge ☐ Debris ☐ Grease

Infiltration: **None** Pipe Seal Cond: **Unknown**
